# **Northern Welsh Recycling**

**PAS 402:2013**

**Publicly Available Annual Report 2024**

**(1<sup>st</sup> January 2024 to 31<sup>st</sup> December 2024)**

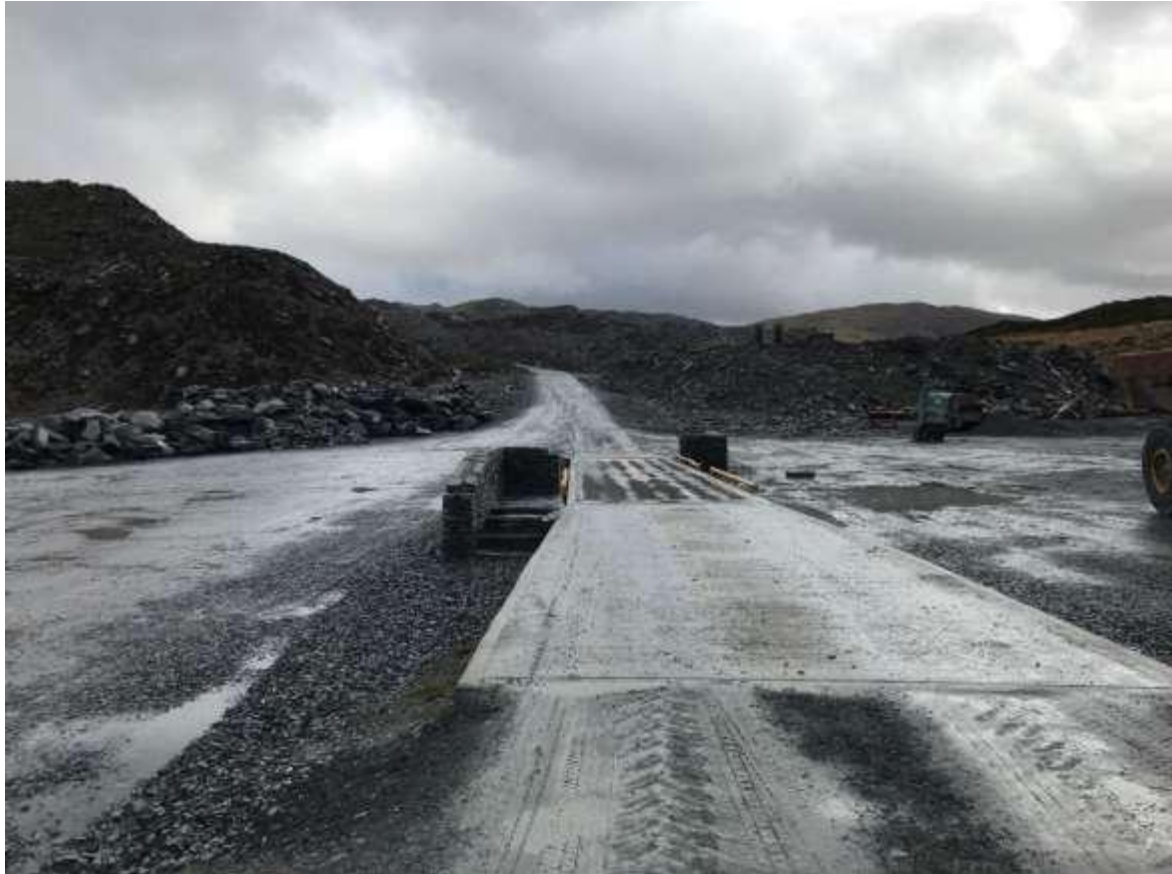
On arrival at site, the load will be weighed using our calibrated weighbridge. The driver shall report to the site office in order to record the details of the load and to complete the relevant paperwork. At this point a visual inspection of the load will also be undertaken before the driver is allowed to tip. If unacceptable wastes are identified, they will be turned away or quarantined before disposal in the appropriate manner if identified after tipping.

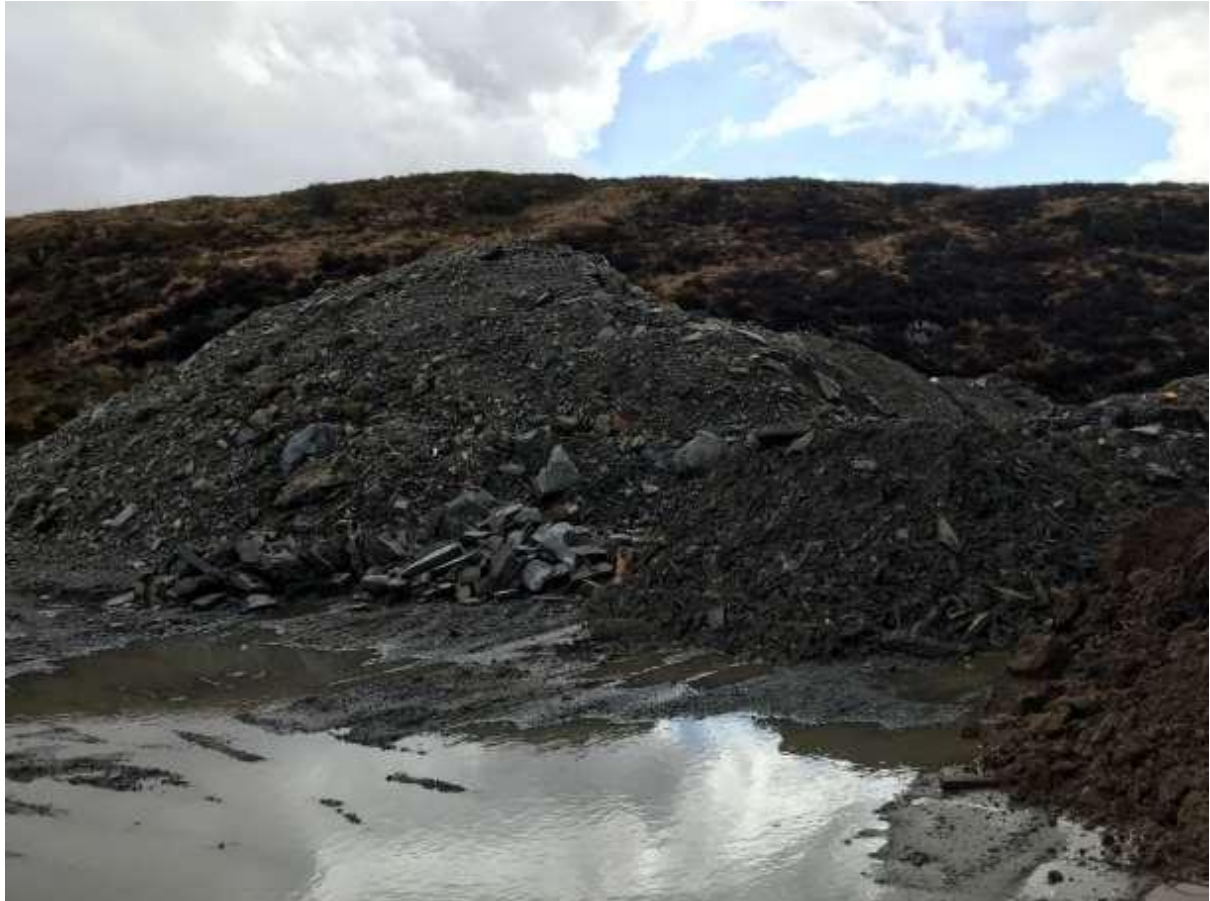
Once a load has been accepted, the driver will be directed to the appropriate bay or area of the site in order to deposit the load. Only one vehicle will be allowed to tip at any one time and all site operatives will be away from the tipping area.

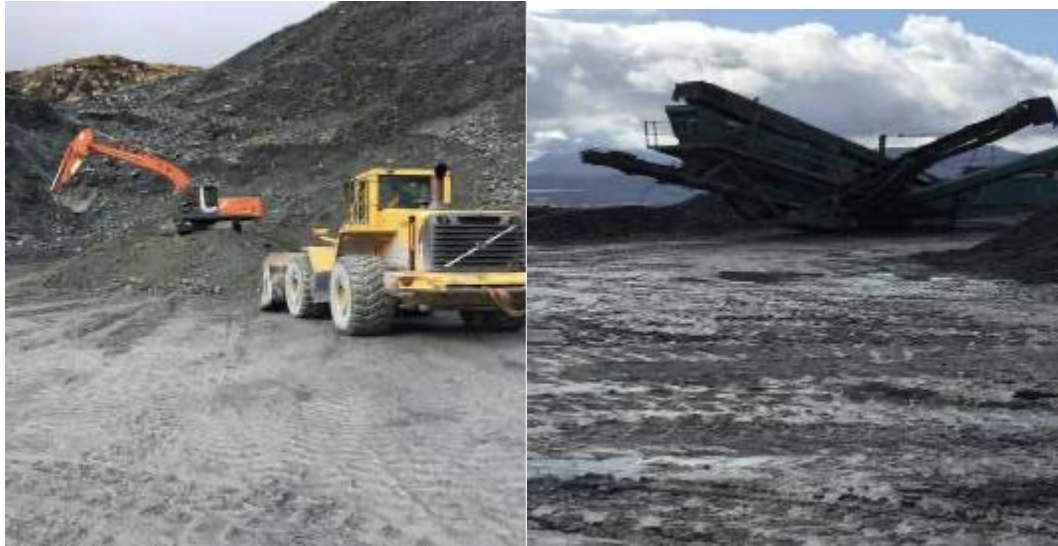
#### **Stage 4 – Processing**

Once enough material is deposited, wastes are to be screened manually and mechanically and crushed to produce various grades of aggregates in accordance with the WRAP Protocol.

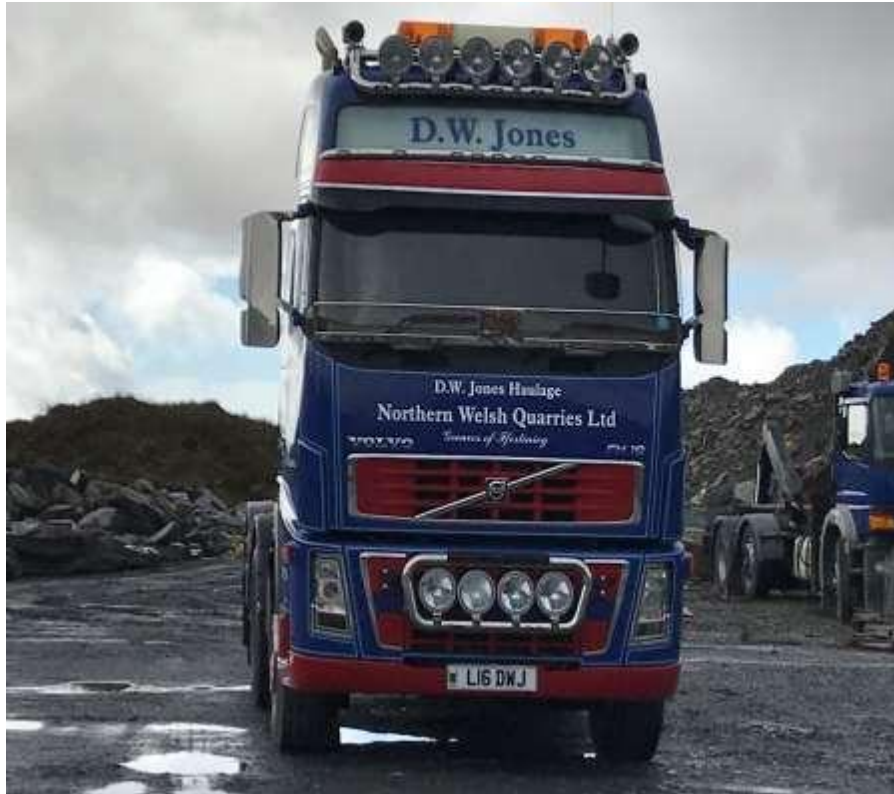
Customers can collect directly from our site, or we are able to take the product directly to the customer. Using a variety of our own HGV vehicles.
